## **4.0 C.U.R.E. MAJOR WORK SUMMARY**

Project CURE (Crude Unit Rebuild Effort): Following the fire, two teams were assembled: an Assessment Team focused on assessing the damage, and a Project Team focused on the rebuilding of the Plant. Many members of the Assessment Team transitioned to the Project Team as assessment work was completed. The Assessment Team was lead by Peter Risse; the Project Team was lead by Marc Evans. Marc Evans also had oversight of the Assessment effort as well. Once the Assessment was completed, Marc Evans took overall ownership of the Project. The following Assessment Teams (Leads) were assembled: Piping and Mechanical (Dan Mason, Brian Blomquist), Machinery (Alan Lowell), Instrumentation (Ed Burghardt), Electrical (Jamie Cabrera), and Civil Structural (Tom Farr).

On January 15, 2007, a fire erupted in the vicinity of the Vacuum Bottoms Pump P-1165A at the No. 4 Crude Unit. There were no serious injuries and the fire was quickly extinguished.

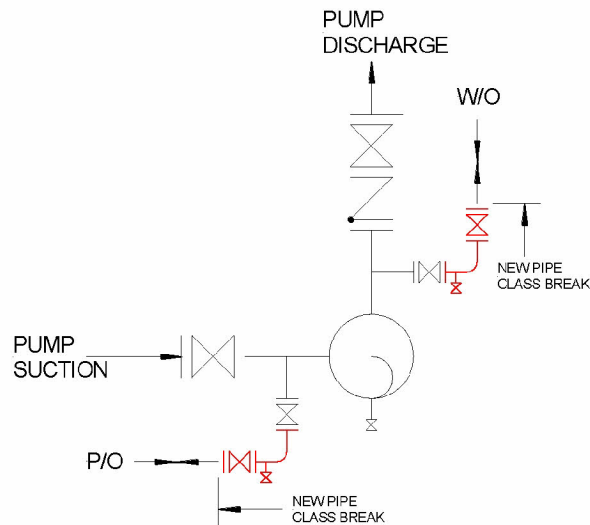
TYPICAL ARRANGEMENT

The schematic below outlines the typical spool arrangements. Bold red lines indicate components that were replaced/upgraded.

BE168-E1 – In response to Fire TapRoot™ Investigation A/C Recommendations #9 and #10 the washoil and pumpout spools on all of the “hot oil” pumps were upgraded to match the respective process stream pipe classes for each pump. A total of thirty-six (36) spools were identified as being coupled to hot oil pumps. All 36 spools were replaced up to and including the second block valve. All 36 spools were upgraded to meet ASME Class 300 requirements. Twenty two (22) spools were metallurgically upgraded to 5Cr – 1/2Mo. One (1) spool was metallurgically upgraded to 9Cr – 1/2Mo. Thirteen (13) spools remained Carbon Steel consistent with the process piping. The intent of these upgrades was to provide full-rated double block & bleed isolation between the process and the washoil and/or pumpout headers. Additionally, these upgrades provide an inherently safe design that will allow the spools to remain in place permanently without risk of over-pressure and with reduced risk of sulfidation corrosion failure.
